NASA CR-134921  
SRD-75-123

## IMPROVED TOUGHNESS OF SILICON CARBIDE

by John A. Palm

GENERAL ELECTRIC COMPANY  
CORPORATE RESEARCH AND DEVELOPMENT

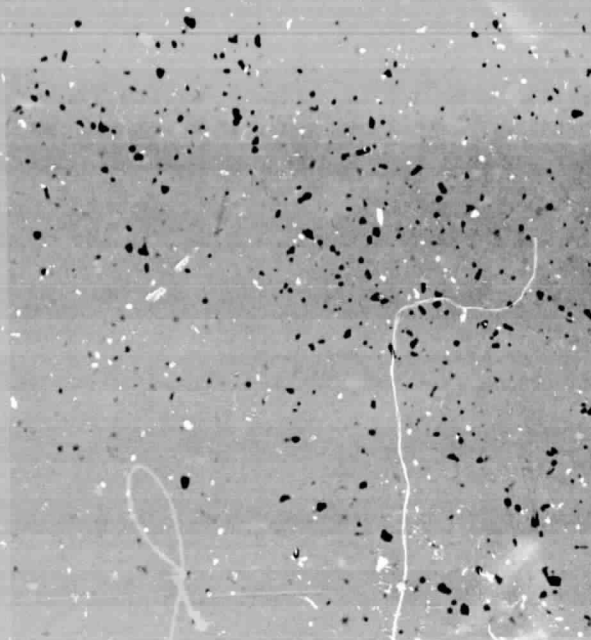
Figure 1. Ceralloy 146A SiC - Polished 263X

A representative sample of Ceralloy 146A hot-pressed ceramic was microscopically examined to establish a baseline character of its microstructure. Figure 1 suggests the material contained a small amount of porosity, probably less than 2 v/o. When the same specimen was thermal etched at  $1550^\circ\text{C}$  in argon for 20 minutes, the microstructure revealed in Figures 2 and 3 was noted. A uniform grain size of between 15 and 20  $\mu\text{m}$  can be measured. Figure 3 was interesting in that it revealed a second phase material which had to a degree become molten during the thermal etching treatment. Microprobe analyses of other silicon-rich SiC materials suggests that this second phase material was also a silicon-rich melt. As indicated by bend strength measurements shown in Table I, the microstructural character of the Ceralloy 146A suggested that at temperatures below which the intergranular second phase material will begin to yield under stress, the structural integrity was considered to be quite good.

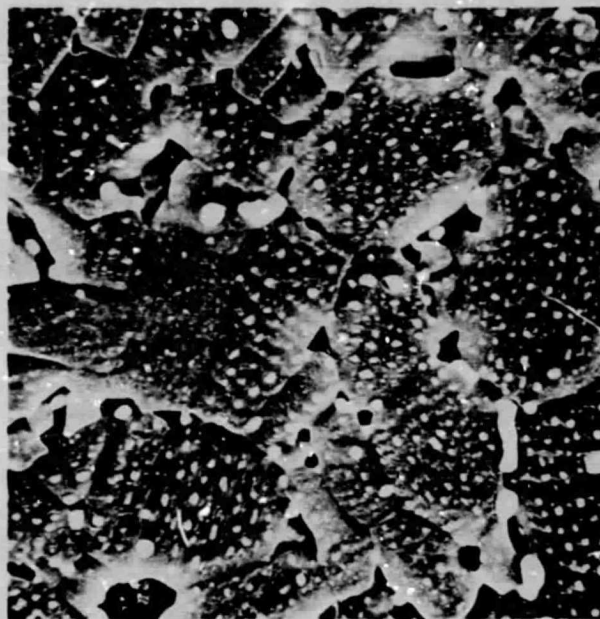
Figure 3. SEM Photomicrograph of Ceralloy 146A SiC - Polished and Thermal Etched at 1550°C for 20 minutes in Argon  
2000X

As can be readily noted there was a serious degradation in the room temperature bend strength, when measured at the test temperature of  $1325^\circ\text{C}$ . This can most likely be related to the presence and high temperature creep character of the second phase material revealed in the SEM photomicrograph (Figure 3).

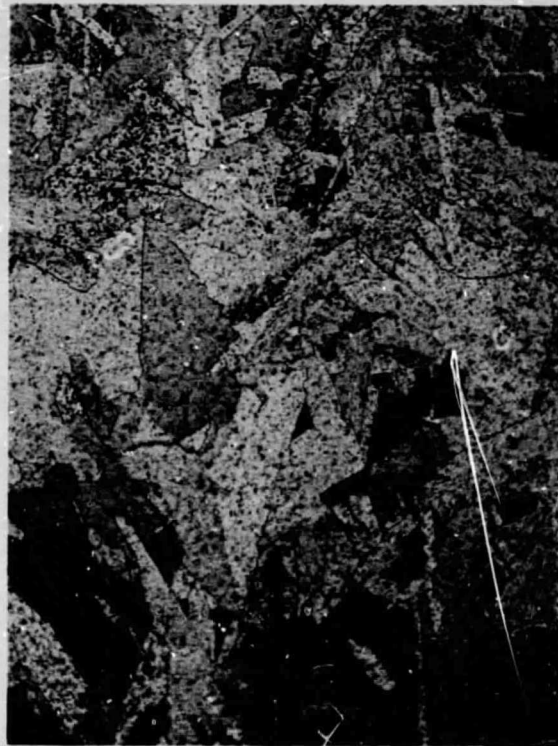
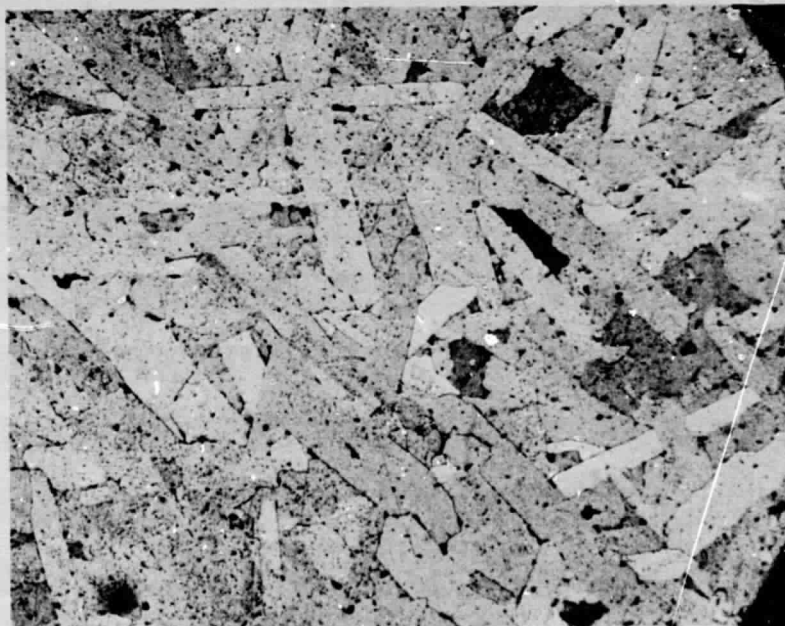
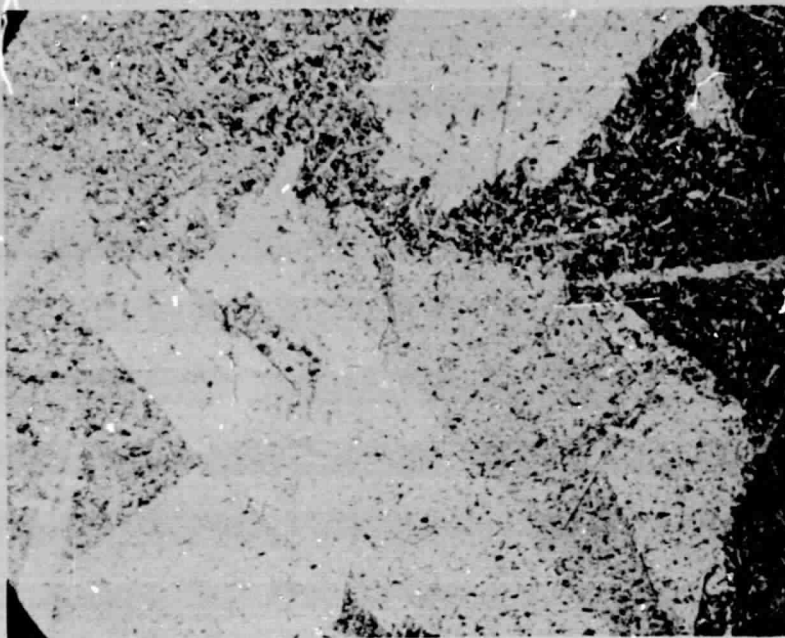
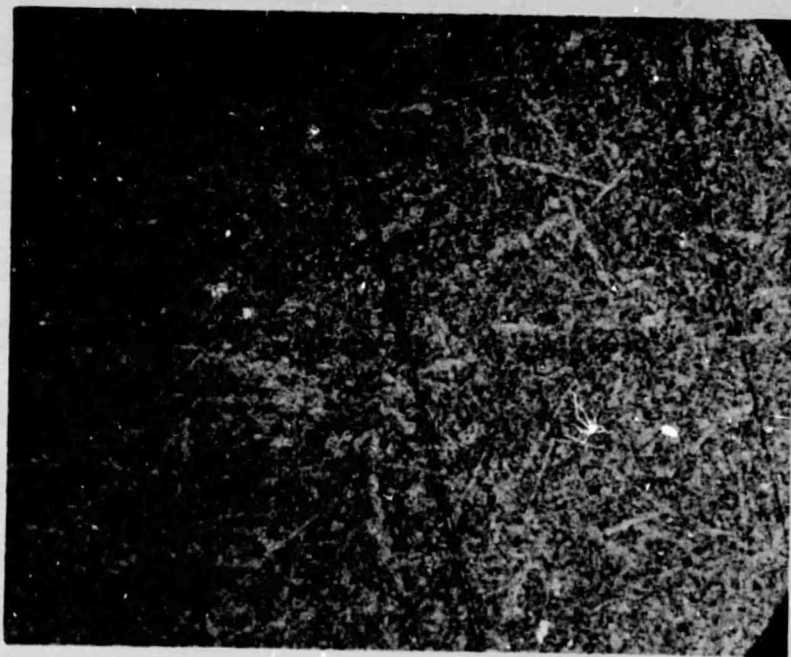
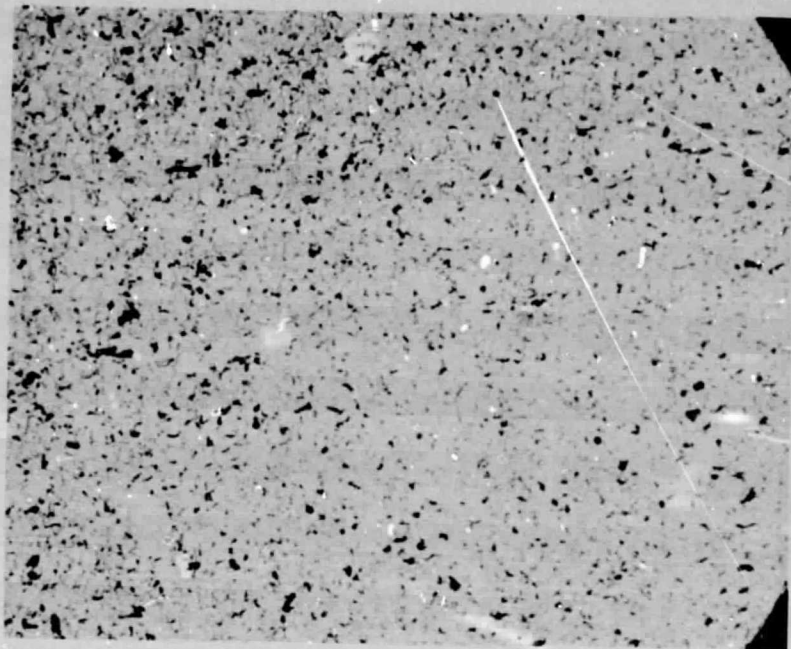
Figures 4 through 10 show the improvement in microstructure achieved by lowering the temperature of hot pressing from 2000°C to 1820°C. Although no significant loss in final density occurred in the 1.91 cm thick specimens when pressed at 2000° and 1820°C, it should be noted that a loss of 2% in density did result. The massive amount of exaggerated grain growth occurring at 2000° and 1900°C hot-pressing temperatures is clearly evident in Figures 4, 5, and 6. Figure 7 shows the 40 to 50 micron needles formed during the hot pressing at 1820°C of the purchased SiC powder. Figures 8, 9, and 10 show the fine-grain microstructure developed in hot-pressed discs made from internally synthesized and formulated SiC powders.

Although it was recognized that because of the large grains present in specimens IHP1A and IHP2, the mechanical properties would be poor and there would be considerable scatter in the results. It was decided to perform Charpy impact tests both at room temperature and at 1325° C using a 1.356 to 2.712 J Charpy test unit. The results are shown in Table V. The tests were performed on unnotched 6.35 mm square x 5.08 cm long Charpy bars using the 1.356 J hammer on the test machine.

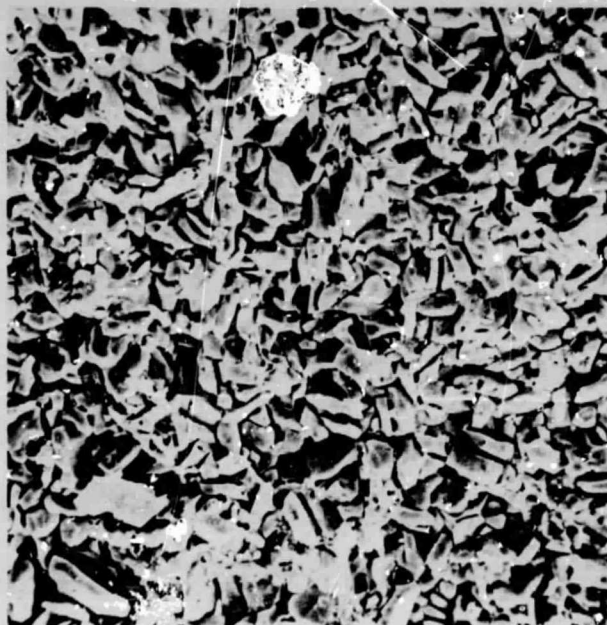
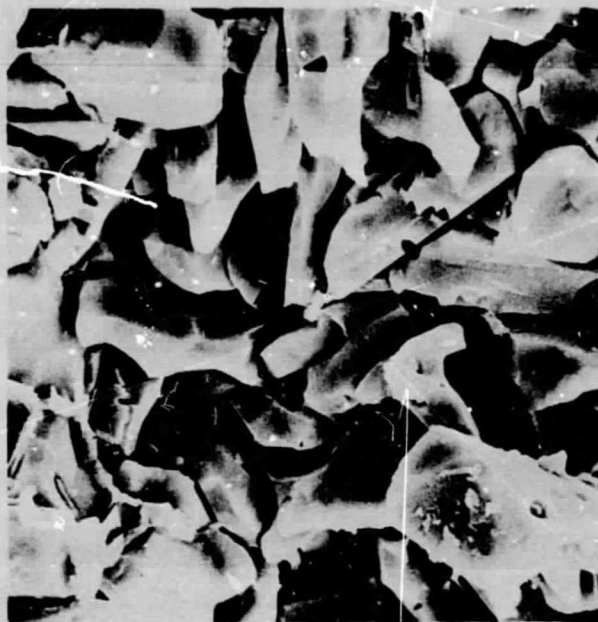
Figures 13 and 14 are SEM photomicrographs of the as-treated SiC surface at 500X and 2000X, respectively. They indicate that a uniform surface structure had been created which had no visible intergranular bond. The fact that it was an abrasion-resistant surface, however, also indicated that the grains were indeed bonded below the visible surfaces.

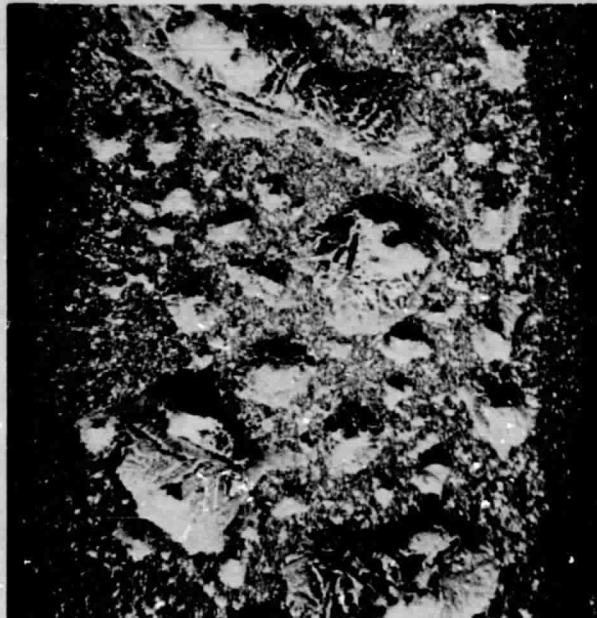
Figure 15. Elemental Si Fusion -Bonded to SiC Substrate 15X

200 Silicon powder, Cat. No. S-164, from the Fisher Scientific Co., was mixed with a solution of ethyl cellulose in amyl acetate and painted on silicon carbide test bars. After evaporation of the amyl acetate, a layer of silicon particles bonded together and to the substrate by the ethyl cellulose remained on the test bar. Removal of the ethyl cellulose was accomplished by pyrolytic decomposition between 1430° and 1475° C. Binder removal was attempted in three different atmospheres: nitrogen, argon, and vacuum. Heating and cooling rates were each 20 minutes long with soak times at temperature of 5 to 30 minutes. Initial results indicated that extremely careful control of atmosphere purity was necessary to prevent oxidation of the silicon during processing. Oxidation to varying degrees occurred in all three atmosphere conditions that were used. In those cases where oxidation was severe, the silicon would not bond to the SiC nor to itself. Where oxidation of the Si was less severe, it apparently formed a good but uneven bond to the SiC substrate. Figure 15 shows the islands of fusion-bonded silicon to silicon carbide. Since the desired and final layer of Si<sub>3</sub>N<sub>4</sub> was required to be both porous and evenly distributed over the surface of the SiC, this approach to that end did not appear to be too promising. The uneven wetting of the SiC by Si was not desirable. Because of this situation, further work was not expected to be worthwhile, and this approach was also terminated.

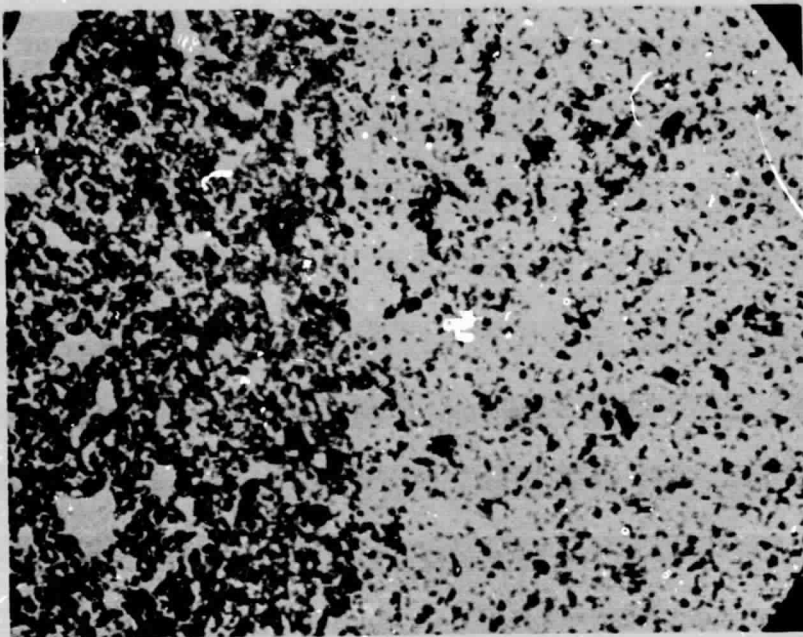
Figure 18. Transition Zone Between Dense  
and Porous SiC by Sintering  
Dipped Layer on Green Compact  
(1 cm = 15  $\mu$ m) 660X

Figure 18 shows the microstructure of a similar duplex structure. It was formed by making a "green" compact, by die-pressing a sinterable SiC powder, and applying the overlay of less sinterable powder by dipping the compact into a liquid suspension of the latter powder. When dry, the green body was sintered to develop the duplex microstructure.

Examination of both Figures 17 and 18 clearly reveals the duplex nature of the bodies. Although a general line of demarcation between dense and porous SiC can be distinguished, it is also evident that there is a continuous phase of dense SiC that connects the two structures. Porous overlays of SiC have been formed in thicknesses up to 2.29 mm by this method.

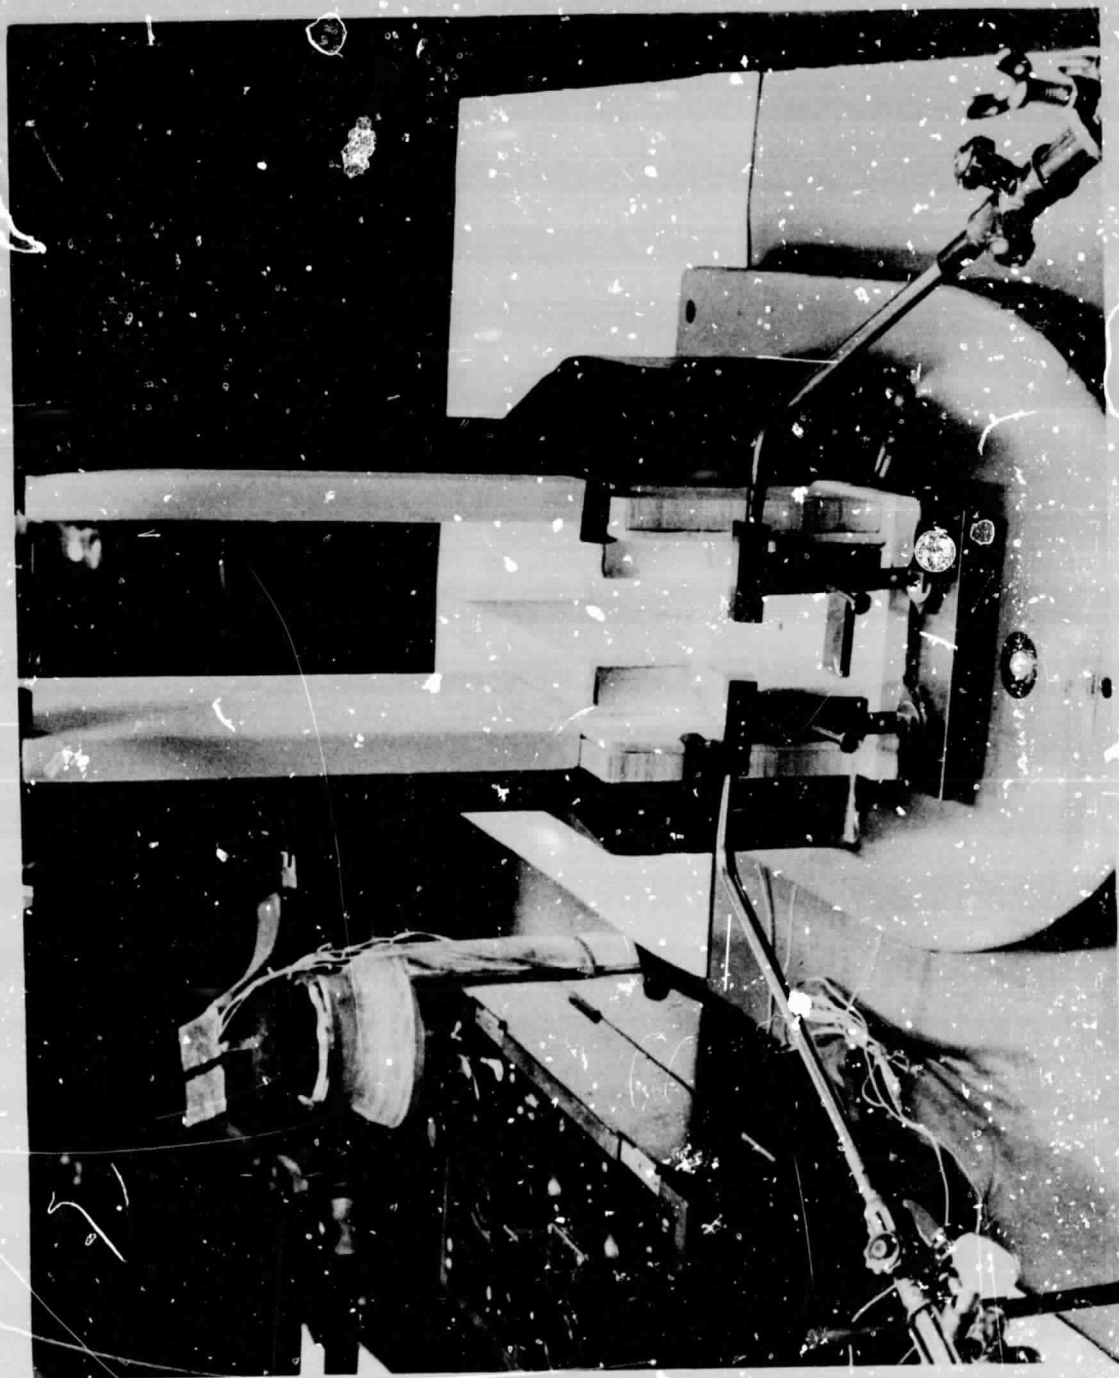
Figure 19. Charpy Impact Tester Assembled for Impact Determinations at 1325° C

Using alumina ceramic, the structure of the Charpy machine was insulated to protect the throat of the machine as well as the upright supports and the hammer support and its bearings. Pyrolytic graphite was used to face the alumina blocks on which the test specimen rested. The pyrolytic graphite was shaped and placed in the equipment so that the test specimen was in contact with the AB planes of the graphite. Excessive heat loss out of the specimen was thus avoided, since the direction in the graphite normal to the two faces of the specimen was in the C or poor thermal conductivity direction. Two hydrogen-oxygen torches were fixed to direct the hot gases onto the specimen.

With a SiC test bar in place and heated to close to 1325° C, the temperature differences between the hottest and "coldest" section of the bar was 10° to 13° C, a variation from the established test temperature of less than 1%. Temperatures were measured by optical pyrometer and with a thermocouple placed in a hole drilled from one end of a bar into its center. Temperature measurements were cross-calibrated between the two techniques to factor out the effects of emissivity. Figure 19 shows the high-temperature assembly in operation with a standard 6.35 mm x 6.35 mm x 3.81 cm unnotched SiC test bar in place. This method of making Charpy impact tests on SiC at temperature proved to be rapid, easy to operate, reproducible in the values determined, and, as indicated above, with a minimum temperature variation across the test bar length, including the supported ends.

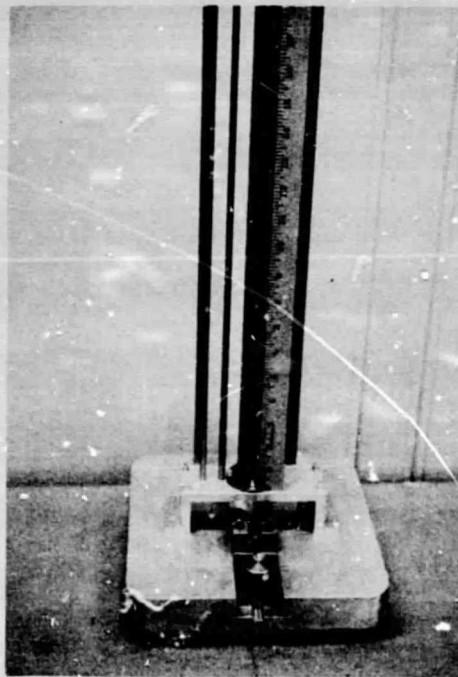
Figure 20. Base and Portion of Impact Device for Producing Hertzian-type Impact Damage in SiC Surface

A test device was built to impart a projectile impact load (Figure 20) to SiC specimens. The device is simply one that allows a body of known weight to fall a measurable distance through an aluminum tube and to impact on the surface of the specimen. The head of the projectile (Figure 21) is a cone of tungsten carbide with its apex machined to a 1.587 mm radius. Teflon rings and guide bar minimize friction losses as the body falls through the aluminum tube.

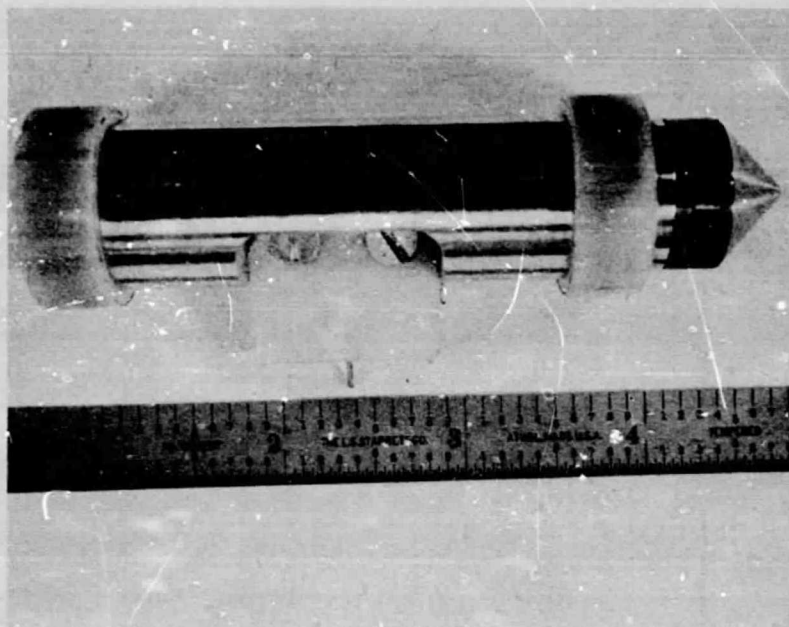
Figure 21. Falling Body Projectile Used to Produce Hertzian-type Impact Damage in Silicon Carbide Surface

Using the test device described above, five bend test bars of hot-pressed SiC were impacted at each of five different impact energies, including an energy level where 80% of the specimens ruptured on impact. Following this, the specimens were subjected to three-point bend test loading and bend strengths were determined for each group of five specimens.

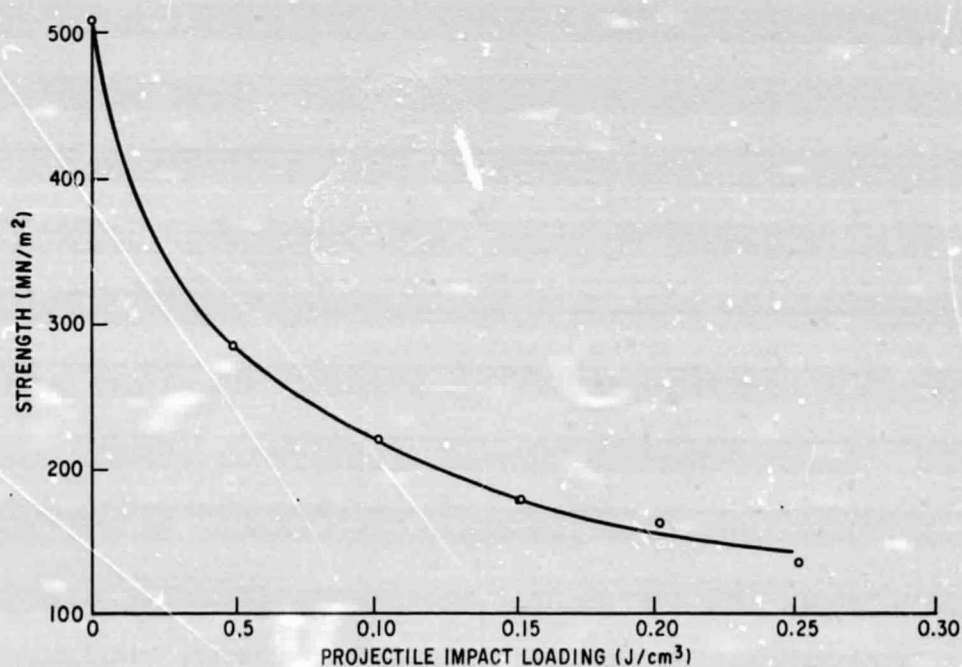
Figure 22. Strength vs Impact Loading Hot-Pressed SiC

Table XIII shows these data and Figure 22 is a plot of the data showing the loss in strength with increasing impact loading. The results of these determinations show a positive correlation between impact loading and bend strength, making it a useful tool for measuring impact damage.
